# Double Tee's

HORIZON TOWERS CONDO ASSOCIATION

# **Analysis of Knott Lab's Proposal to Evaluate Horizon Towers Structural Issues**

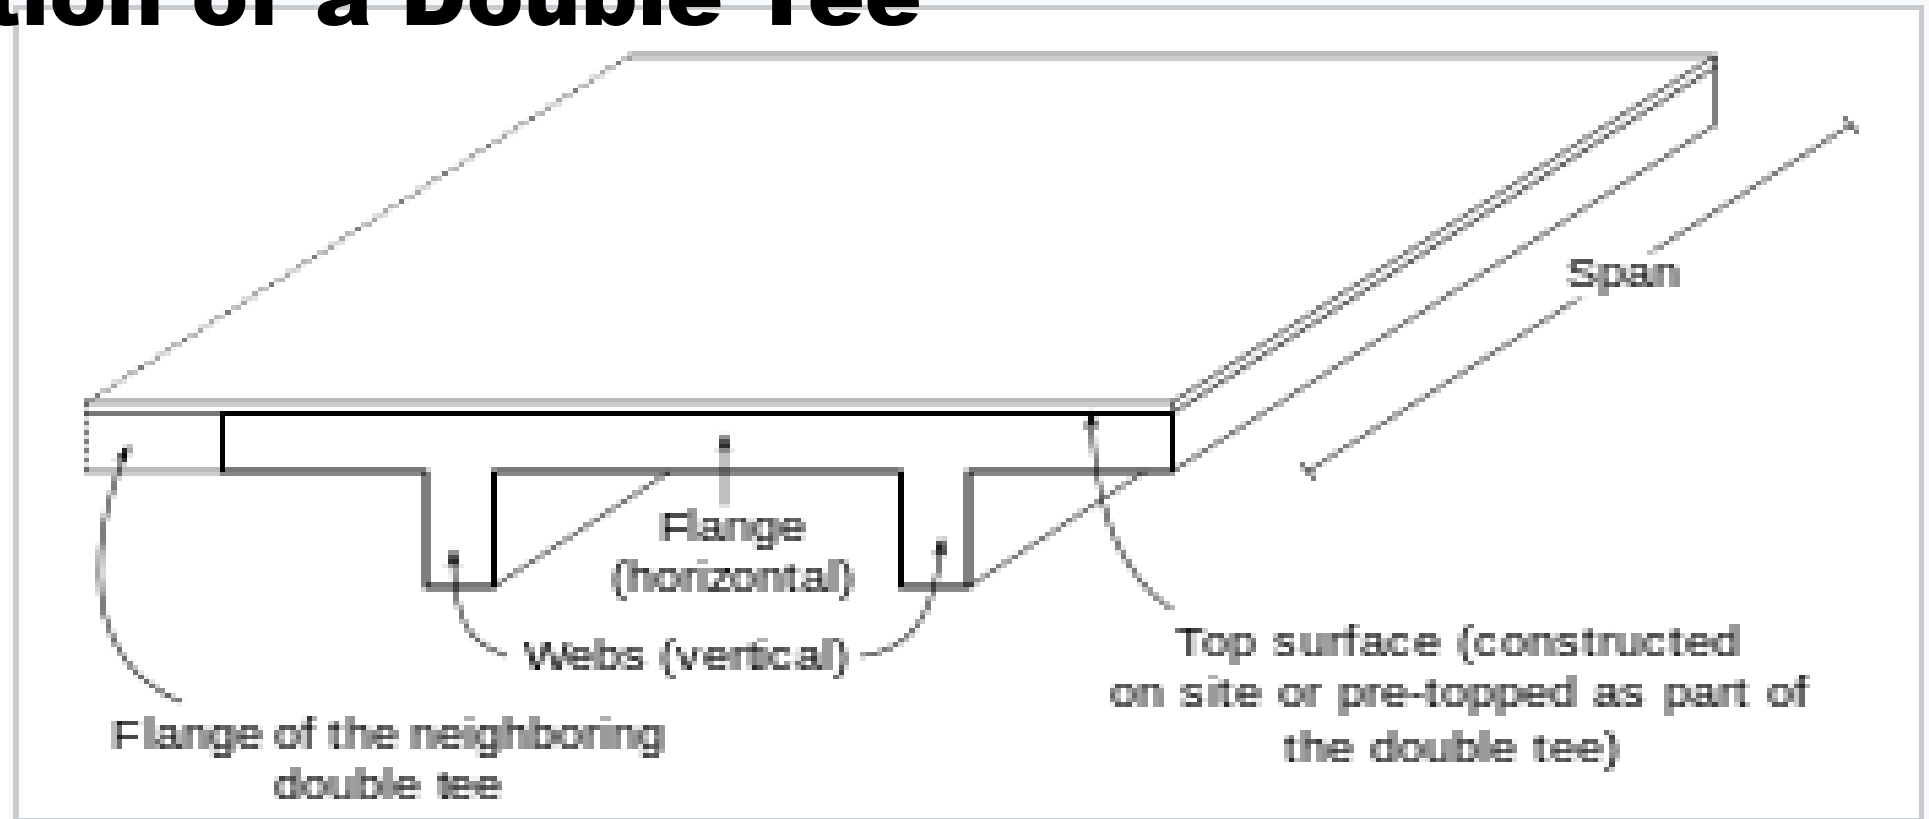
# Illustration of a Double Tee

A **double tee** or **double-T** beam is a load-bearing structure that resembles two [T-beams](#) connected to each other side by side. The strong bond of the flange (horizontal section) and the two webs (vertical members, also known as stems) creates a structure that is capable of withstanding high loads while having a long span. The typical sizes of double tees are up to 15 feet (4.6 m) for flange width, up to 5 feet (1.5 m) for web depth, and up to 80 feet (24 m) or more for span length. Double tees are pre-manufactured from [prestressed concrete](#) which allows construction time to be shortened.
